Evaluation, Design and Implementation of a Holistic Repair Strategy to Extend the Service Life of the Post-Tensioned Wando River Bridge

IBC 24-85

The James B. Edwards Bridge is a post-tensioned segmental box girder bridge that carries I-526 over the Wando River in Charleston, SC. The structures have experienced corrosion of PT tendons with grout deficiencies, which overtime eventually led to corrosion and tendon failures. In response SCDOT teamed up with engineering consultant HDR and proactively evaluated the post-tensioning in both structures. They jointly developed a comprehensive strategy to mitigate corrosion and extend the service life of the structures.

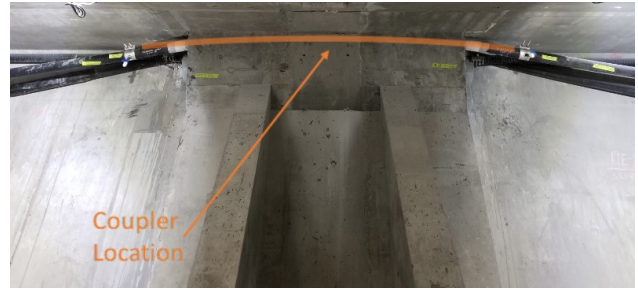
Figure 15: Tendon across diaphragm - Condition 1

An example of Condition 1 is shown in Figure 15.

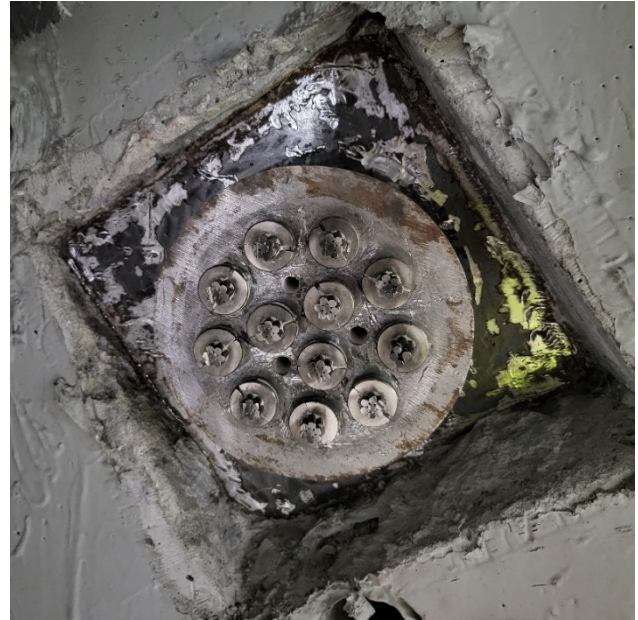
Figure 16: Grout cap and grout removed, with wedge plate and tendon tails cleaned and prepped for testing and PTI Impregnation

Depending on the condition and geometry, impregnation or venting was often necessary at the tendon anchors. In these locations, the existing anchor protection and grout caps were removed. After the wedge plate and strand tails were cleaned and prepared (Figure 16), new caps that included a port were installed (Figure 17).

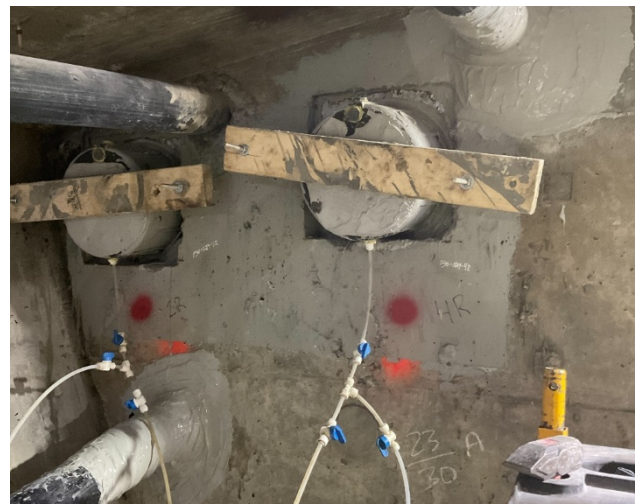
Figure 17: Grout Cap Installed with Impregnation Port

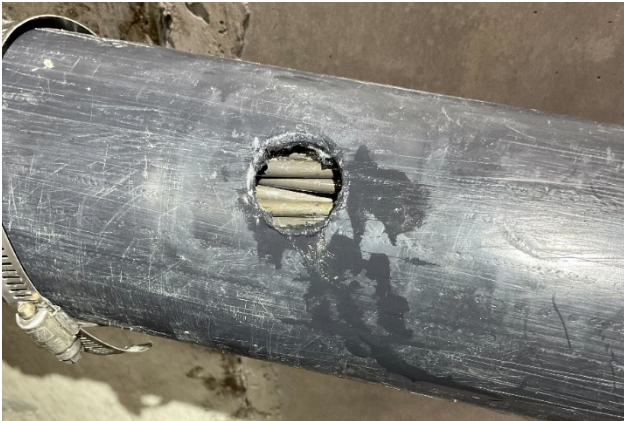
Figure 18: Side of Tendon Opened and Prepared for Port Installation

Along the length of the external tendon port locations were prepared by removing a small portion of the tendon duct and grout to expose the strands. Ports were installed at the prepared locations (Figures 18 and 19).

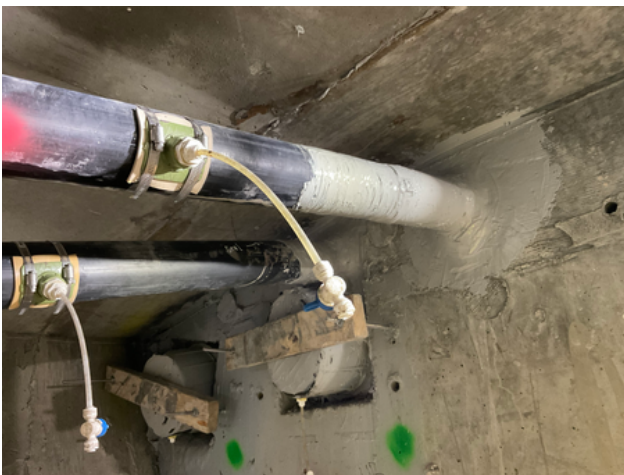
Figure 19: Tendons and Anchor Caps Ported.

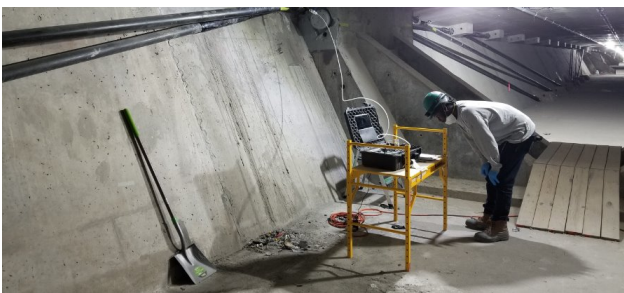
Figure 20: Moisture Testing Prior to PTI Impregnation

Once the ports were installed, leak testing was performed to verify communication of air between the ports installed on the tendon and to identify potential leaks. Cracks and transitions (duct to concrete) where air leaking occurred were sealed with an epoxy paste. Moisture testing was then performed to evaluate the tendons for the probability of corrosion (Figure 20).

tendon was in the "high" range, or where free visible water was found in the port, the process of 'micro-drying' was used. Microdrying reduces high moisture levels along segments of a tendon utilizing dried compressed air. Once the moisture level of the tendon is below threshold levels, the PTI Impregnation process can proceed.

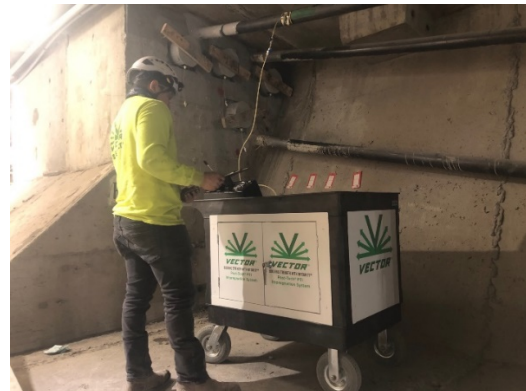
Figure 21: PTI Technician Monitoring the Impregnation of a Tendon

Tendons were impregnated using a combination of pressure pumps and vacuum devices. For Conditions 1 and 2, and for full-length tendons with couplers (Condition 3), impregnation was considered complete when the material was visible at an outlet port, indicating it had reached the intended limits of the tendon length to be impregnated, or there was evidence that it had reached the anchor. For full-length tendons with anchors (Condition 3) and full-length main span tendons (Condition 4), the pressure was maintained for a specified period of time after it was visible at an outlet port and the anchor.

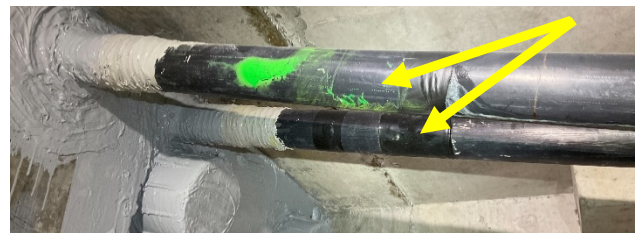
Figure 22: Repaired Port Locations After PTI Impregnation

After completion of the PTI Impregnation, the side ports in the tendon ducts were drained, grouted, and then wrapped with a heat shrink seal (Figure 22). For tendon impregnation that included anchorages, the fluid was drained from the grout cap, the grout cap was filled with grout and it was sealed with an elastomeric coating (Figure 23).

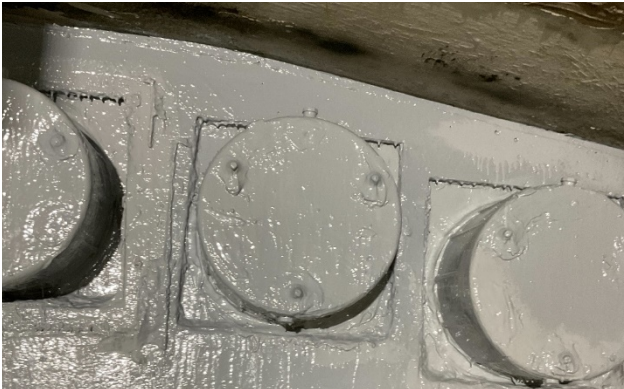
Figure 23: Repaired Grout Caps Sealed with Elastomeric Coating after PTI Impregnation
