Mitigating Corrosion on the **Big Creek Bridge:** Bridge Preservation and Apocalyptic Conditions

Introduction

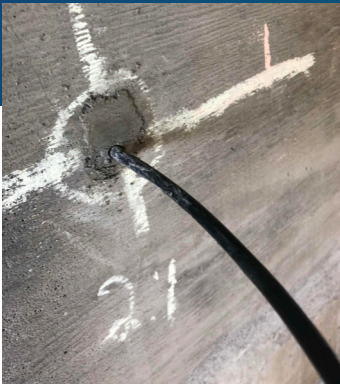
Cathode wire connection to the reinforcing steel

Installation of the ECE system started with making cathode connections by locating the reinforcing steel using Ground Penetrating Radar, drilling a $\frac{3}{4}$ -inch hole to the steel, and making a mechanical connection to the steel. For each monitored sub-zone, a minimum of two electrical contacts were made with a maximum of 500 sq. feet per connection to ensure balanced current distribution.

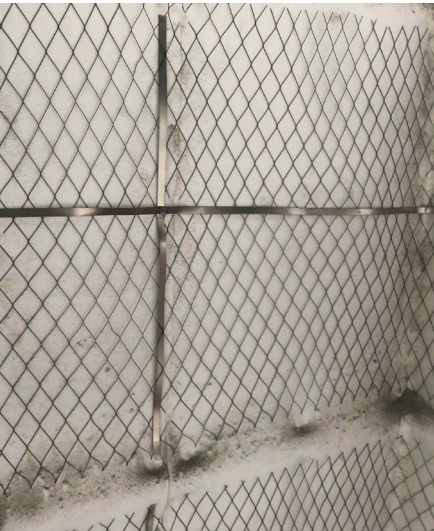
Titanium mesh with welded titanium distribution bar

The anode mesh was wired with two leads running from the junction box to each sub-zone. The redundancy of multiple leads prevents any of the sub-zones from going untreated during the treatment process in case of a connection failure. Each pair of anode lead wires was tested for continuity to ensure good connections to the titanium mesh. A low voltage DC rectifier was set to negatively charge the reinforcing steel and positively charge the titanium anode mesh.

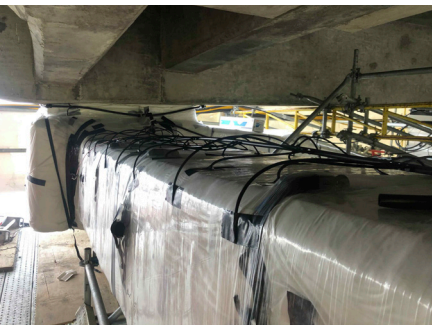
Cellulose matting wrapped in plastic sheet with drip hoses

To keep the cellulose matting wet throughout the treatment, irrigation lines were laid over the horizontal and vertical surfaces to ensure every square foot of the cellulose matting would become saturated with potable water. The water supply hose was connected to a holding tank on top north end of the bridge, and a sump pump was placed within the holding tank to help force water to all areas being treated.

The structure was then covered and wrapped with 6mm clear plastic to retain as much moisture as possible in the cellulose matting.

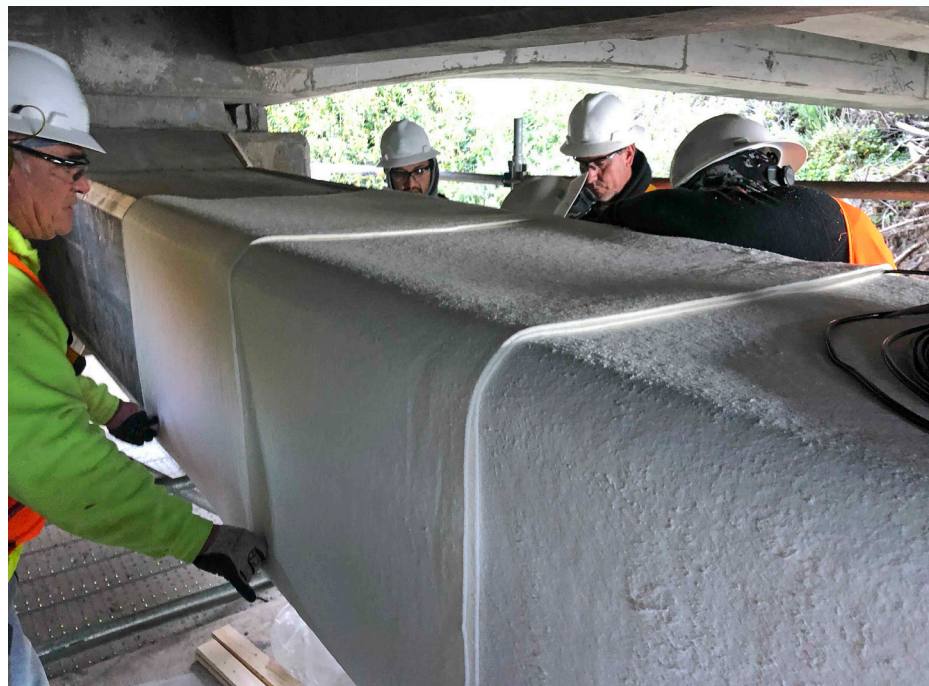
Cellulose fabric attached to concrete surface

Next, two layers of $\frac{1}{4}$ -inch cellulose matting were attached to the surface of the concrete using plastic anchors to avoid electrical shorts. The cellulose matting acted as the conductive media that distributed the current uniformly over the surface of the concrete, and also as a spacer between the titanium mesh anode to keep it off the concrete surface.

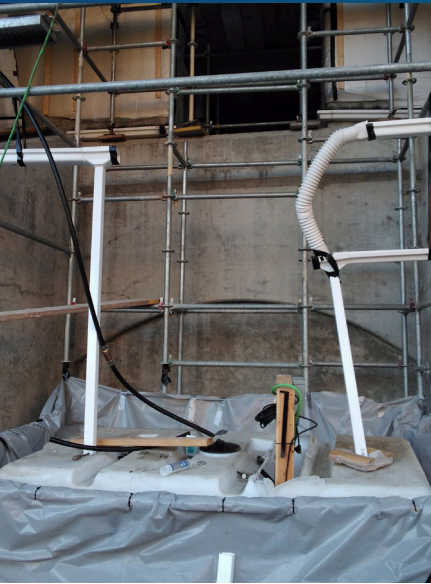
Collection tank placed at the bottom of each pier to capture waste water for recirculation

A visual inspection was also carried out daily to ensure there was no problem with the watering system. The potable water pump, storage tank, and irrigation lines were checked and the cellulose matting was monitored throughout the day for dry spots. As potable water ran through the system, it navigated the concrete members and was ultimately captured in a holding tank at the base of each pier. A jet pump was used to move the water from the base of the pier back to the holding tank at the top of the bridge.

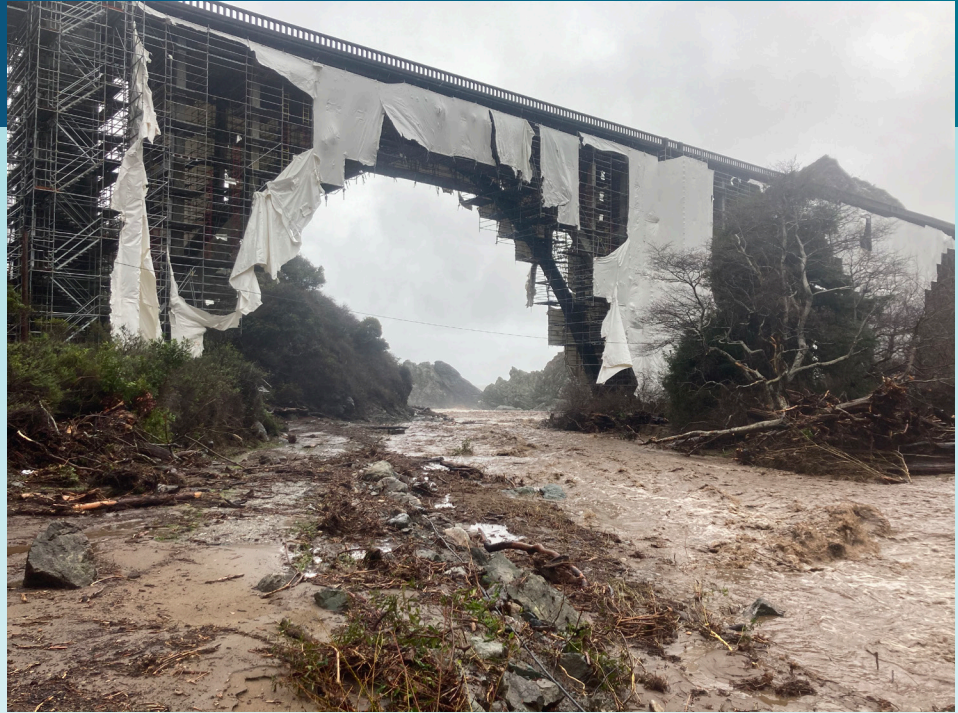
Aftermath of heavy winds and flooding

If that wasn't crazy enough, fast forward to January 2021 when a wicked winter windstorm with gusts up to 44 mph lashed the site and actually ripped the enclosures off the bridge.

Being in an actual canyon, you can imagine that all this heavy rain triggered flash floods that made its way down the valley and striking the scaffolding with debris. A scaffold company was called in to assess the damage. After the scaffolding was repaired the team got back to work.

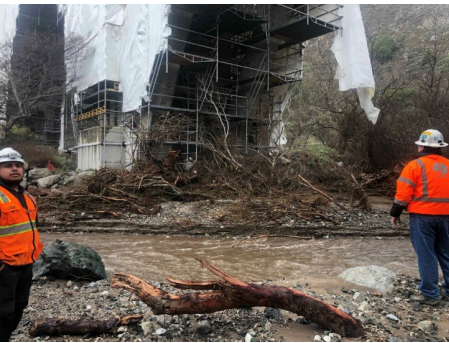
Flooding and debris

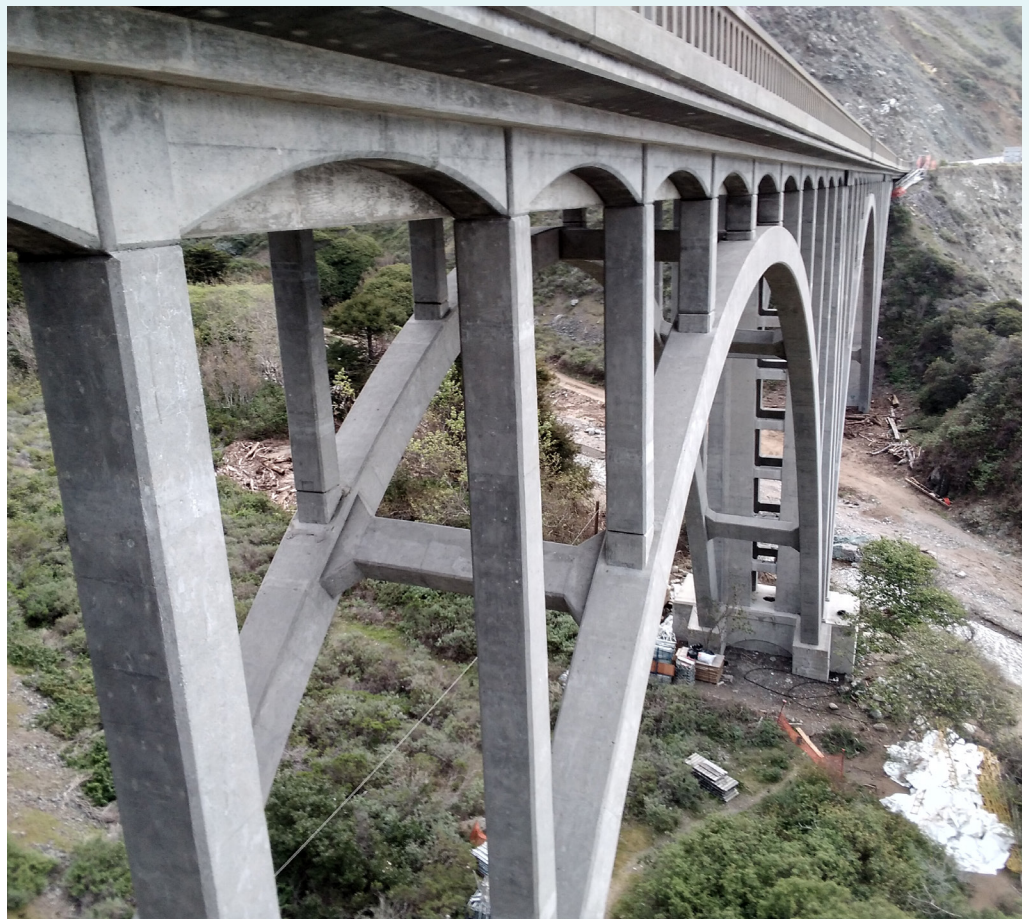
Completed ECE Treatment on Big Creek Bridge

The ECE treatment of the arches, spandrel columns, struts, and piers on the Big Creek Bridge was successful and will extend the useful service life of the structure. The treated area was 54,556 sq. feet and the post-treatment chloride concentrations averaged 138 PPM at the level of the rebar, which is below the threshold for corrosion in addition to the increase in alkalinity which occurs as a result of performing ECE.
