Evaluation, Design and Implementation of a Holistic Repair Strategy to Extend the Service Life of the Post-Tensioned Wando River Bridge

IBC 24-85

The James B. Edwards Bridge is a post-tensioned segmental box girder bridge that carries I-526 over the Wando River in Charleston, SC. The structures have experienced corrosion of PT tendons with grout deficiencies, which overtime eventually led to corrosion and tendon failures. In response SCDOT teamed up with engineering consultant HDR and proactively evaluated the post-tensioning in both structures. They jointly developed a comprehensive strategy to mitigate corrosion and extend the service life of the structures.

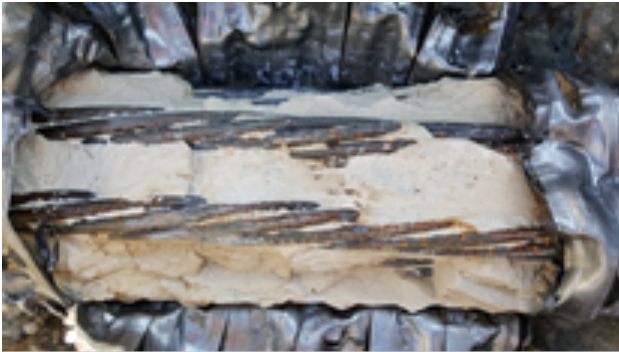
Figure 6: PT Tendon Opening

Non-destructive testing can be used to identify areas of concern and areas with high probability of voids. Visual inspection of PT tendons in certain identified areas is recommended to confirm the results and allow visual inspection of tendon condition in these areas and allow grout samples to be collected for testing (Figure 6).

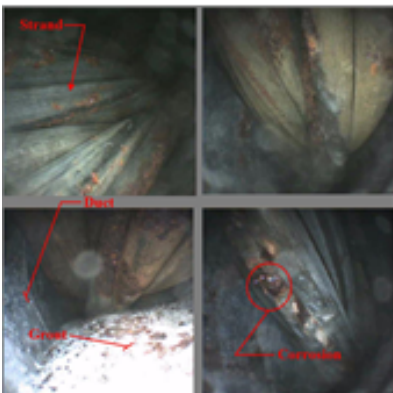
Figure 7: Borescope Images

As an alternative to making large openings to visually inspect a section of a PT tendon, in some cases it may be preferred to make a small hole, typically less than 1 inch in diameter and use a borescope to determine the size of a grout void and to inspect the condition of the exposed strands (Figure 7).

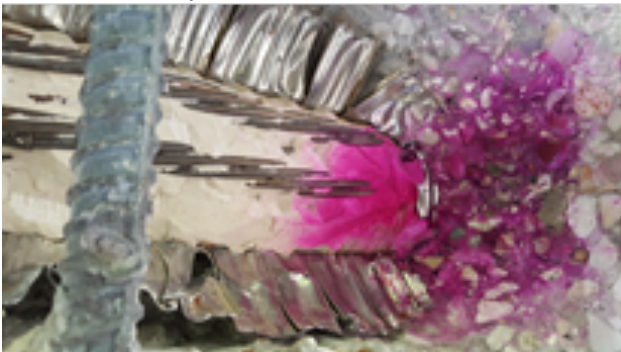
Figure 9: Field Carbonation Depth Testing at PT inspection Opening

Carbonation testing can be conducted in the field (Figure 9) by immediately spraying the freshly exposed concrete or grout surface with a 0.15% solution of phenolphthalein in ethanol. The solution turns pink when applied to surfaces with a pH greater than 10. The solution will remain colorless if the surface pH is less than 10, indicating carbonation is present.

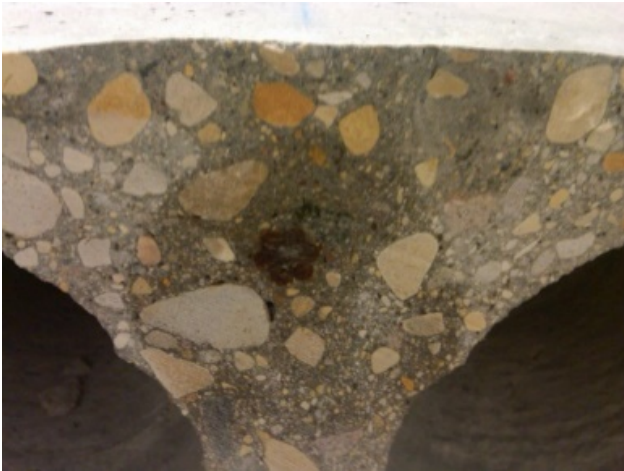
Figure 14: Concrete surrounding a single seven wire strand shows a radial pattern of Impregnation

The impregnation material is introduced into the tendon and is able to travel along the tendon as illustrated in Figure 12 and Figure 13. The material, which flows inside an individual strand, is able to seep between the wires of the strand into the grout surrounding the strand as shown graphically in Figure 12 and Figure 13, as well as photographically in Figure 14.
